ROAD MAP TRACK 6
Innovative Concrete Pavement
Joint Design, Materials, and
Construction

MAP Brief 6-1:

**Preventing Joint Deterioration in
Concrete Pavements
A Summary of Current Knowledge**

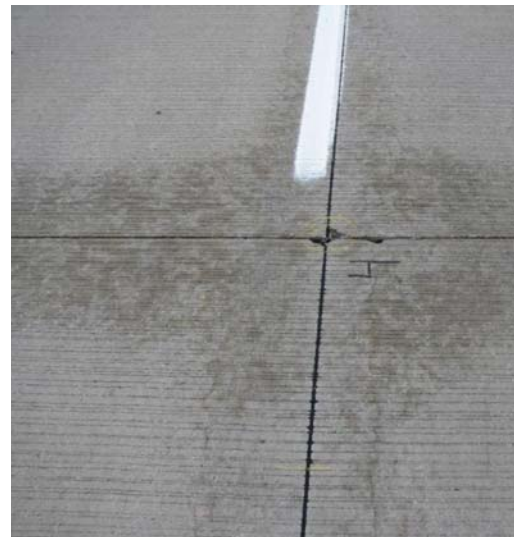
in pavements ranging in age from 5 to 15 years old. The distress is often initially observed as shadowing (Figure 1), because microcracking near the joints traps water; later, the joint exhibits significant loss of material (Figure 2).

Figure 1. Typical shadowing

1. Apply surface sealants to the faces of and near existing joints to reduce ingress of water into the concrete

- Siloxane-based materials have a proven history of reducing permeability of concrete systems. These materials are sprayed on and will have to be re-applied periodically —probably about every 5 to 7 years.
- Other sealant types are being investigated.

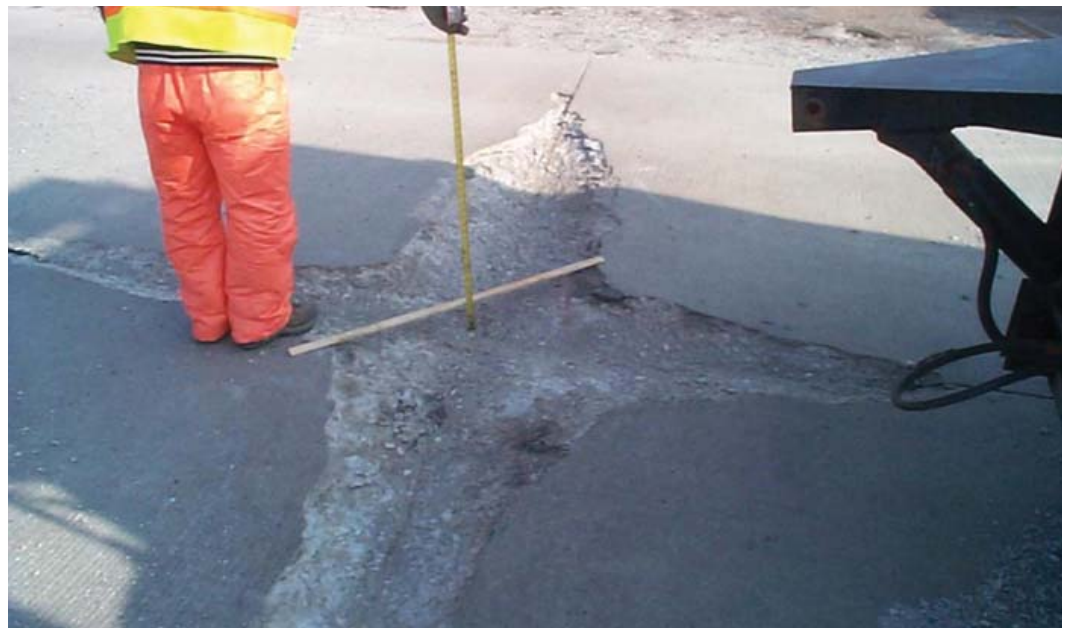
Figure 2. Loss of material

2. Consider limiting the type of deicing salts to sodium chloride.
3. Partial / full depth repairs of the joints may be required if the serviceability of the pavement is compromised. In some cases it is reported that the damage is through the full depth of the pavement meaning that a full depth repair is required. Damage limited to the top 1/3 to top 1/2 of the depth may be addressed using a partial depth repair.
4. Pay attention to maintenance of drainage systems including regular inspection and cleaning.
5. Consider retrofitting edge-drains to improve drainage.

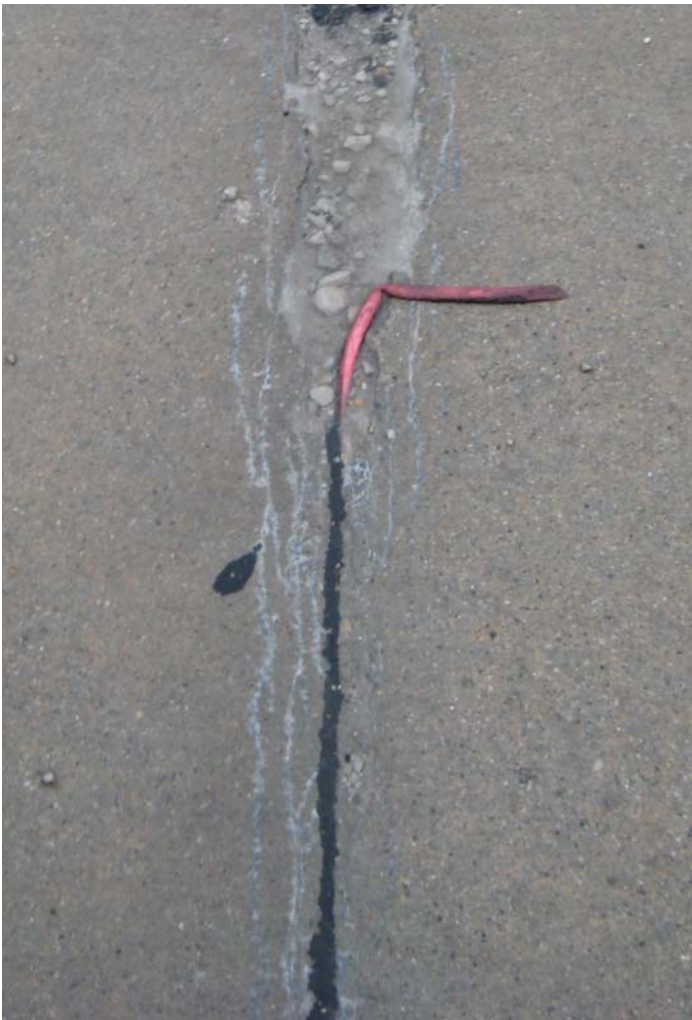
- Concrete that has been saturated for longer periods (Figure 3) has a significantly higher risk of distress, regardless of the source of water.
- Many distressed pavements have been found to have marginal air void systems.
- A variety of potentially aggressive de-icing salts may have been used on these surfaces.
- Once damage starts, it progresses rapidly.

Water that is trapped in a joint will result in longer periods of saturation and thus provide greater risk of freezing-related

damage. Water can be trapped behind a failed seal, above a non-cracked joint, or in the joint if the base layer is impermeable.

Figure 3. Evidence of concrete saturation

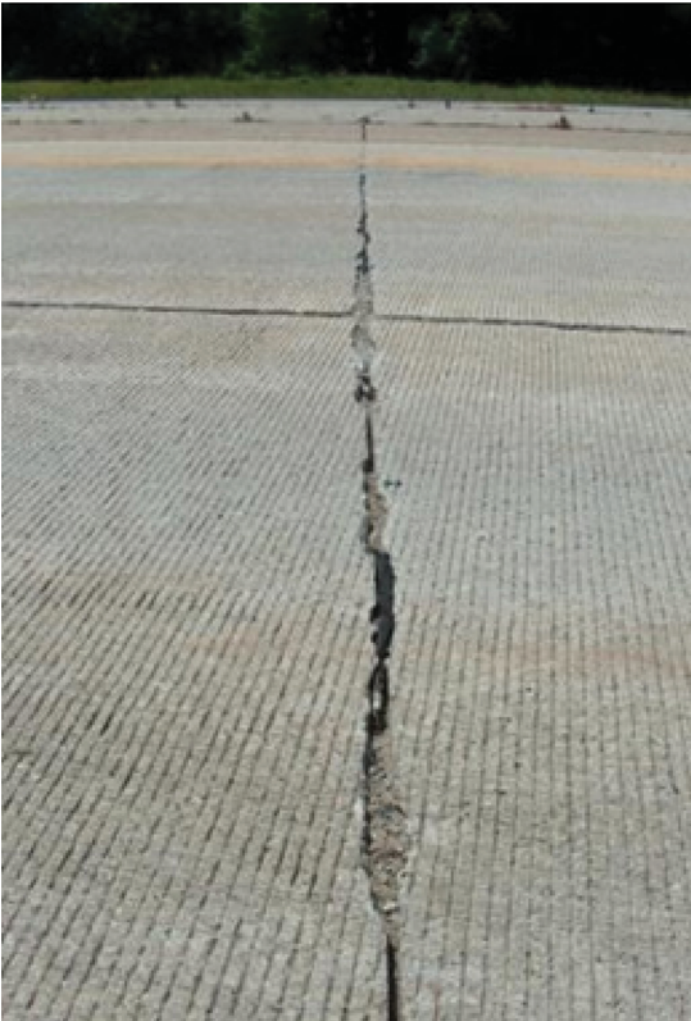
In the second, mechanical, form of deterioration (Figure 4), typical characteristics are as follows:

- Damage is normally narrow and shallow, and may be on only one side of the joint.
- Damage starts near the edge of the slab and propagates along the joint rather than outward.
- The cracks often appear around aggregate particles rather than through them, indicating that the first damage may have occurred in the first few hours after placing.

It is likely that poor maintenance of the sawing equipment and/or inappropriate sawing practices are leading to damage around the saw cut that may not be visible initially, but will be exercised and opened up by weathering. Such damaged areas will also tend to act as water traps, thus leading to accelerated freezing-related distress, as described above.

Figure 4. Typical mechanical distress

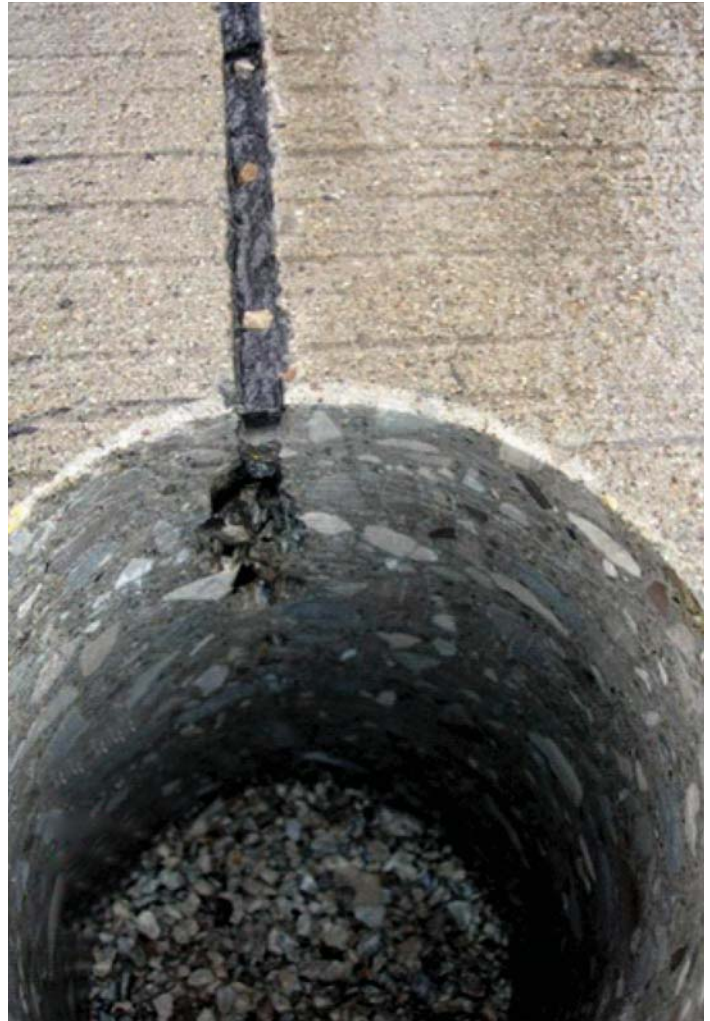
Figure 5. Example of damage occurring in a slab that has not cracked out

- Ensure that the saw cuts initiate a crack so that water can get away (Figure 5), for instance make sure the longitudinal saw cuts are at least T/3 in depth.
- Ensure that the base has some permeability to allow
