ROAD MAP TRACK 7

**Pavement Joint Deterioration:  
Recent Findings to Reduce the  
Potential for Damage**

**MAP Brief June 2015**

**Concrete Pavement Joint Deterioration:  
Recent Findings to Reduce the Potential  
for Damage**

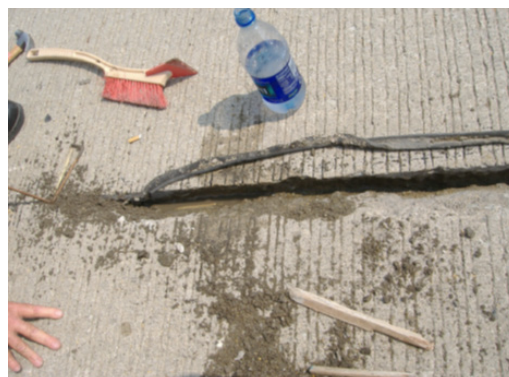
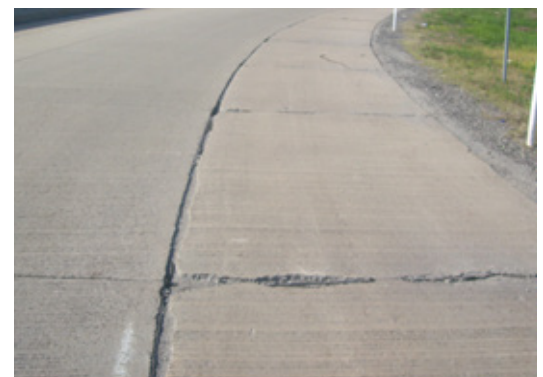
Figure 1: Typical examples of joint deterioration of concrete pavements in Indiana

While many concrete pavements provide excellent long-term performance, some concrete pavements have exhibited premature deterioration, primarily at joints and saw-cuts (Figure 1). This joint deterioration is problematic because it compromises the performance and service life of an otherwise healthy concrete pavement. Repairing these joints can be expensive, and these repairs are disruptive to the travelling public.

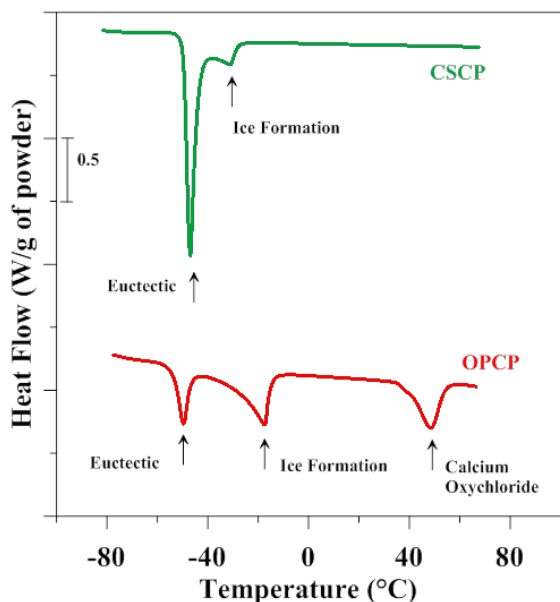
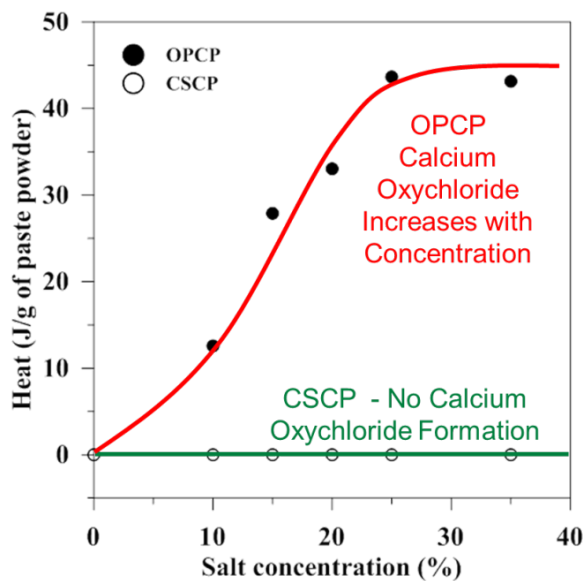
Figure 3: a) Typical LT-DSC plot illustrating the heat flow associated with phase changes – notably the phase change associated with formation of calcium oxychloride and b) the amount of calcium oxychloride that has formed

The calcium oxychloride phase change occurs when calcium hydroxide from concrete reacts with calcium chloride in the presence of water (between 0°C and 50°C depending on salt concentration) [18]. This reaction can be observed by measuring the heat flow of a sample using low-temperature differential scanning calorimetry (LT-DSC). The LT-DSC test is performed by cooling a powdered hydrated cementitious material to -80°C then reheating the material at a slow rate and measuring the heat release due to phase transformation. Figure 3a provides an example of a conventionally hydrated cement paste (OPCP) and a paste (CSCP) that does not contain tri calcium aluminate or calcium hydroxide which was formed by carbonating a silicate cement [19].

It can be observed that the OPCP sample shows three features as it is heated. At approximately -50°C the eutectic solid changes phase becoming a highly concentrated salt liquid (the concentration is the eutectic composition). In the range between the eutectic temperature to ~ -15°C (depending on the concentration of salt), the ice that formed during freezing (pro-eutectic ice) gradually melts resulting in the second feature in the heat flow curve.

The third feature in the heat flow curve occurs at temperatures approximately 50°C and are associated with the formation of calcium oxychloride. By integrating the heat flow peak associated with the calcium oxychloride, the total heat released can be obtained (which is related to the amount of calcium oxychloride that has formed) (Figure

3b). It can be observed in comparing the OPCP system (with calcium hydroxide, CH) and the CSCP system (a system without calcium hydroxide, CH) when CH is not present, calcium oxychloride cannot form and as a result the samples do not show damage.

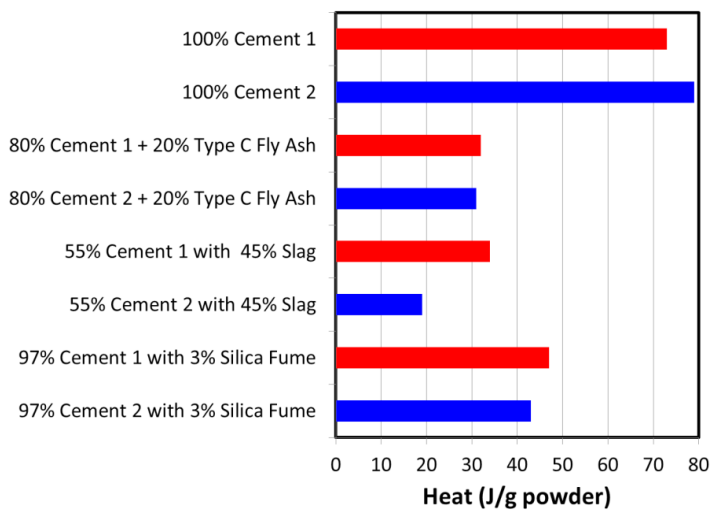
Figure 4: An example of the role of cementitious binder on the heat release associated with the formation of calcium oxychloride

Figure 4 illustrates results from LT-DSC testing on two cementitious systems where conventional Type I portland cement systems are compared with those systems containing SCM (20 % Class F Fly Ash, 45 % Slag, and 3 % silica fume mass replacements). It can be noticed that the chemistry of the cement has some impact on the amount of calcium oxychloride that forms, and is presumably due to the amounts of tricalcium aluminate (C<sup>3</sup>A) and the ratio of tricalcium silicate (C<sup>3</sup>S) to dicalcium silicate (C<sup>2</sup>S), and the degree of hydration as this will influence the amount of calcium hydroxide that is produced.

the SCM. For the limited materials used in this study, the following observations can be made. The calcium oxychloride was reduced to 39%-44% of that of the straight cement system when 20% Class C fly ash was used. The calcium oxychloride was reduced to 24%-46% of that of the straight cement system when 45% slag was used to replace cement. The calcium oxychloride was reduced to 54%-64% of that of the straight cement system when 3% silica fume was used. While the amounts of reduction will vary depending on the concentration and chemical composition of the components, it can be noticed that in each case the use of the SCM resulted in a substantial reduction in the amount of calcium oxychloride formation, which results in less damage in the concrete.
